**Flood Control Project Maintenance
Levee Inspections**
LMA District Cover Sheet
Spring 2018 Levee Inspection Results

Reclamation District No. 1500 Sutter Basin

Spring 2018 Levee Inspection Results

Waterway			Bank	Unit Miles
Unit No. 01 Sacramento River			Left	33.15
	Spring (March - May)	Summer (June - August)	(September - November) Fall	Winter (December - February)
Unit Maintenance Rating (Fall Only)				
Date of Inspection	3/27/2018 - 3/28/2018			
DWR Inspector	Zach Jojola			
Accompanied By	Hiromi Tomita RD 1500

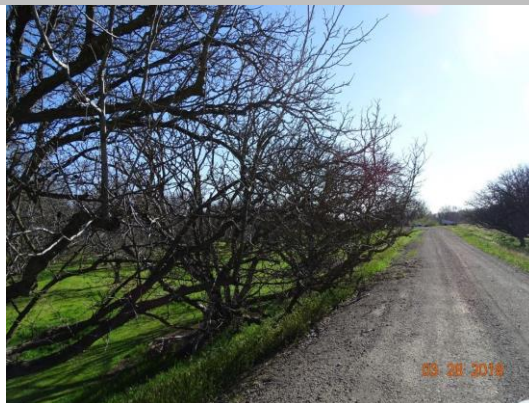
Photo 1 of 2 : SP_2018_RD1500_189_137_20180329_00241.jpg

LM Start	0.07	Rating **	M	Issue No.	137
LM End	0.07	Issue Type +	Ma	Location *	LS
Category	Earthen Levee			GPS Latitude/Longitude	
				Start	End
Item	Trim / Thin Trees			38.761077 °	38.761077 °
				-121.675851 °	-121.675851 °
DWR ID	DWR_RD1500_01_f_2016_137				
Comment Code					
T1 : Trim trees to at least five feet above ground level.					
Inspector Comment					
Trim limbs on landside slope.

View of tree over the landside slope. Spring 2018.

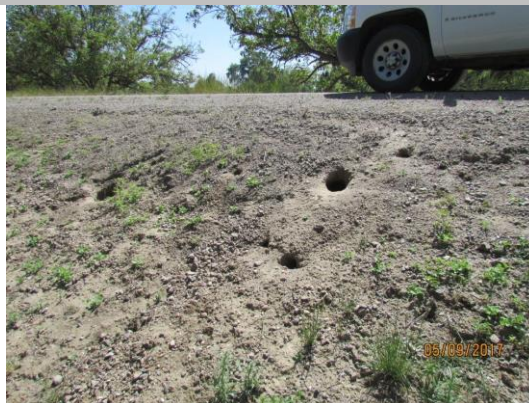
Photo 1 of 1 : SP_2018_RD1500_189_155_20180306_00079.jpg

LM Start	0.26	Rating **	M	Issue No.	155
LM End	0.26	Issue Type +	Ma	Location *	LS
Category	Earthen Levee			GPS Latitude/Longitude	
				Start	End
Item	Animal Control			38.762584 °	38.762584 °
				-121.678542 °	-121.678542 °
DWR ID	DWR_RD1500_01_s_2017_155				
Comment Code					
A3 : No rodents visible, but rodent burrows visible; need to backfill and compact or grout burrows.					
Inspector Comment

View of rodent holes on landside slope. Spring 2017.

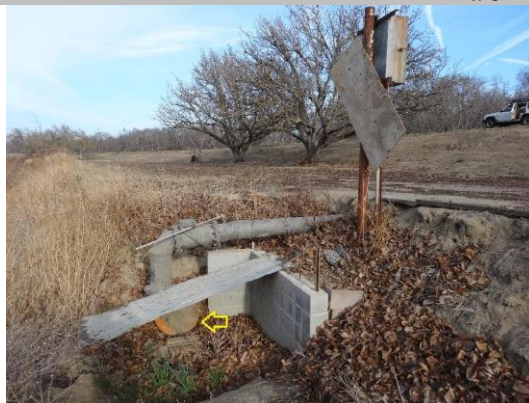
Photo 1 of 3 : UCIP_SP_2018_28183_51845.jpg

Comment Code						
Inspector Comment						
FS_ID:28183 DS_ID:20032 EP_NO: 1566A Repair Type: Non-Urgent Crossing Status: Found UCIP Comments: - soil erosion around headwall on waterside.- pump was removed.- overhead powerline. FIELD_STRUCT_DESC: *REPLACEMENT CROSSING* 10-inch coated steel irrigation discharge pipe through the levee, 5 feet below the crown. Pump and switch panel on the waterside (WS) berm. Service pole on WS shoulder. Siphon breaker on the landside (LS) slope. 3-foot by 4-foot concrete distribution box at the LS toe. (Replacement of an existing pipeline through the levee authorized under Permit No. 1566-A, 1980 - Ralph White Jr.). [Additional Reference(s): DWR Levee Log, 2005. USACE Sacramento O&M Manual 128, March 1960, (HLM 0.30), 8-inch pipe referenced]. FS Date: 1/9/2014

WS view: concrete blocks headwall and pump on river bank. Pump has been removed (marked). Surface erosion around headwall.

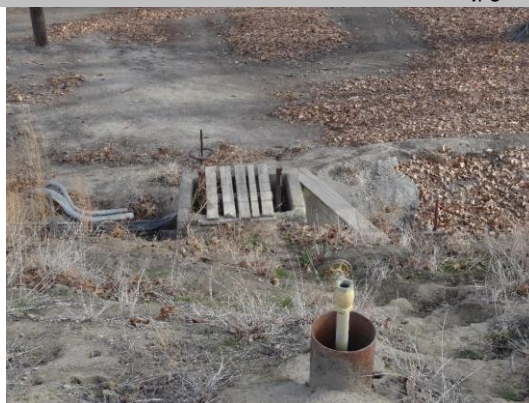
Photo 2 of 3 : UCIP_SP_2018_28183_51844.jpg

LS view: pressure breaker (bottom) in steel pipe riser and concrete distribution box on levee toe.

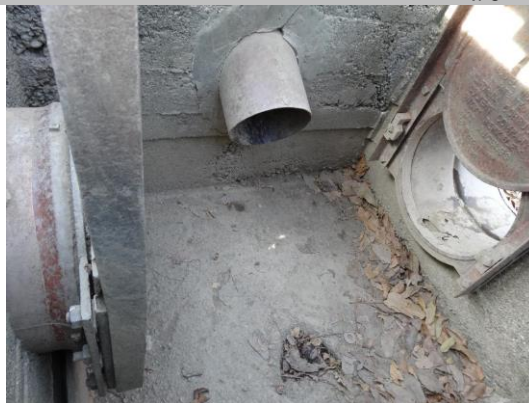
Photo 3 of 3 : UCIP_SP_2018_28183_51843.jpg

Comment Code						
Inspector Comment						
FS_ID:28183 DS_ID:20032 EP_NO: 1566A Repair Type: Non-Urgent Crossing Status: Found UCIP Comments: - soil erosion around headwall on waterside.- pump was removed.- overhead powerline. FIELD_STRUCT_DESC: *REPLACEMENT CROSSING* 10-inch coated steel irrigation discharge pipe through the levee, 5 feet below the crown. Pump and switch panel on the waterside (WS) berm. Service pole on WS shoulder. Siphon breaker on the landside (LS) slope. 3-foot by 4-foot concrete distribution box at the LS toe. (Replacement of an existing pipeline through the levee authorized under Permit No. 1566-A, 1980 - Ralph White Jr.). [Additional Reference(s): DWR Levee Log, 2005. USACE Sacramento O&M Manual 128, March 1960, (HLM 0.30), 8-inch pipe referenced]. FS Date: 1/9/2014

LS view: open steel pipe in concrete distribution box on levee toe.

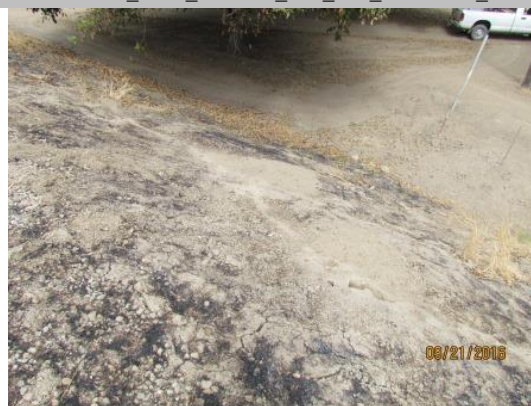
Photo 2 of 2 : SP_2018_RD1500_189_135_20180306_00071.jpg

LM Start	0.32	Rating **	M	Issue No.	135 (cont)	
LM End	0.32	Issue Type +	Ma	Location *	LS	
Category	Earthen Levee			GPS Latitude/Longitude		
				Start		End
Item	Animal Control			38.763265 °		38.763265 °
				-121.679075 °		-121.679075 °
DWR ID	DWR_RD1500_01_f_2016_135					
Comment Code						
A3 : No rodents visible, but rodent burrows visible; need to backfill and compact or grout burrows.						
Inspector Comment						
Rodent hole halfway down landside slope.

Rodent activity on LS slope. Fall 2016.

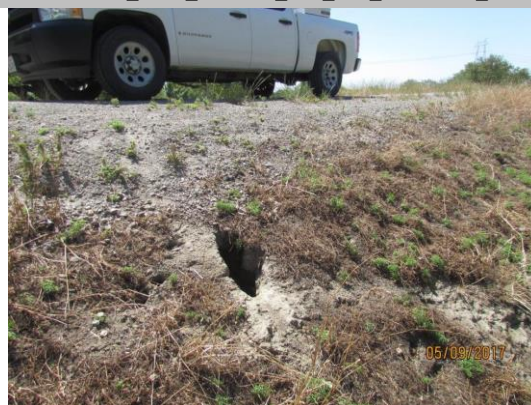
Photo 1 of 1 : SP_2018_RD1500_189_151_20180306_00077.jpg

LM Start	0.34	Rating **	M	Issue No.	151
LM End	0.34	Issue Type +	Ma	Location *	
Category	Earthen Levee			GPS Latitude/Longitude	
				Start	End
Item	Animal Control			38.763473 °	38.763473 °
				-121.679300 °	-121.679300 °
DWR ID	DWR_RD1500_01_s_2017_151				
Comment Code					
A3 : No rodents visible, but rodent burrows visible; need to backfill and compact or grout burrows.					
Inspector Comment

View of rodent holes on landside slope. Spring 2017.

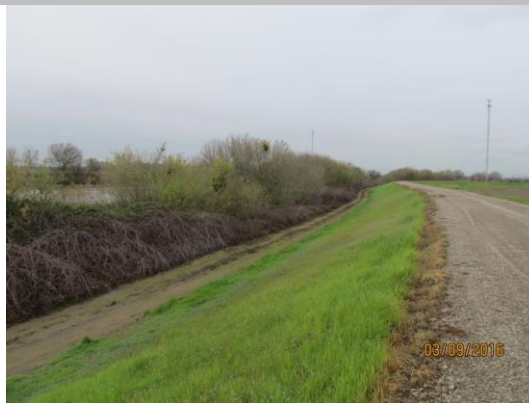
Photo 1 of 2 : SP_2018_RD1500_189_72_20180306_00039.jpg

LM Start	0.56	Rating **	A/W	Issue No.	72
LM End	0.82	Issue Type +	Ma	Location *	WS
Category	Earthen Levee			GPS Latitude/Longitude	
				Start	End
Item	Vegetation			38.764462 °	38.764638 °
				-121.683167 °	-121.687690 °
DWR ID	DWR_RD1500_01_s_2018_72				
Comment Code					
V8 : Environmental Requirements.					
Inspector Comment

View of the revegetation site on the waterward side toe of the levee looking upstream. Spring 2016.

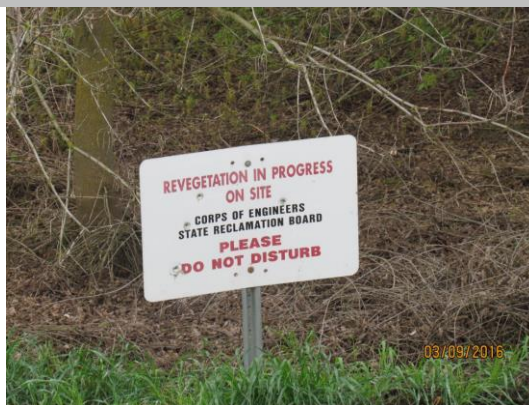
Photo 2 of 2 : SP_2018_RD1500_189_72_20180306_00040.jpg

Sign is located at the toe of the levee on the waterward side. Spring 2016.

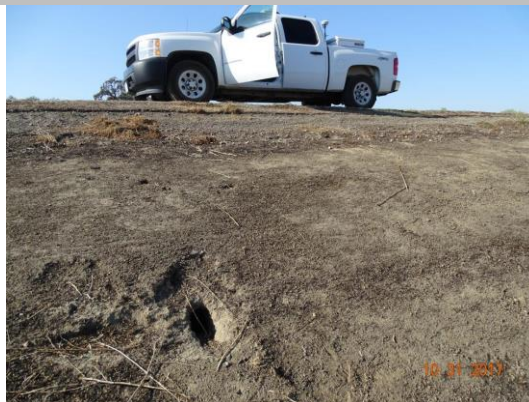
Photo 1 of 1 : SP_2018_RD1500_189_100_20180306_00051.jpg

LM Start	1.10	Rating **	M	Issue No.	100
LM End	1.10	Issue Type +	Ma	Location *	LS
Category	Earthen Levee			GPS Latitude/Longitude	
				Start	End
Item	Animal Control			38.767407 °	38.767407 °
				-121.691589 °	-121.691589 °
DWR ID	DWR_RD1500_01_s_2018_100				
Comment Code					
A3 : No rodents visible, but rodent burrows visible; need to backfill and compact or grout burrows.					
Inspector Comment					
Multiple holes on landside slope ad berm.

View of hole on landside slope and berm. Fall 2017.

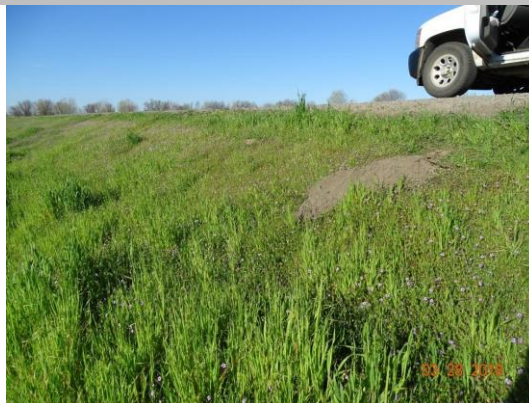
Photo 1 of 2 : SP_2018_RD1500_189_99_20180329_00240.jpg

LM Start	1.25	Rating **	M	Issue No.	99 (cont)
LM End	1.25	Issue Type +	Ma	Location *	LS

Updated view of rodent holes. Spring 2018

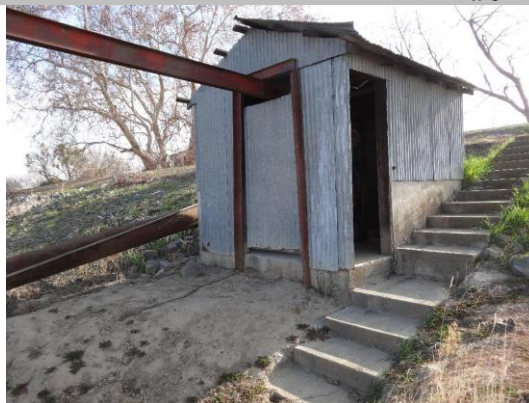
Photo 1 of 3 : UCIP_SP_2018_28903_53162.jpg

Comment Code					
Inspector Comment					
FS_ID:28903 DS_ID:20094 EP_NO: 10080 Repair Type: Non-Urgent Crossing Status: Found UCIP Comments: Pump removed from concrete pad and kept inside pump house (may be for storage purpose) on waterside.A 8-inch steel pipe inside 14-inch pipe. FIELD_STRUCT_DESC: 1 of 2: 14-inch steel irrigation discharge pipe through the levee, 5.2 feet below the crown. Pump in a corrugated metal pump house on the waterside (WS) slope. Butterfly valve on the WS. Concrete staircase on the WS slope. 1.75-inch galvanized iron water line with faucet exposed on the landside (LS) slope, 3.4 feet below the crown. 4-foot by 5.7-foot concrete distribution box at the LS toe. 1.25-inch conduit through levee, 2 feet below the crown. (14-inch steel irrigation discharge pipe through the levee and pump in a corrugated metal pump house on the WS slope authorized under Automatic Board Order (ABO) issued as Permit No. 10080, 1974 - Sebastian Yturralde). [Additional Reference(s): DWR Levee Log, 2005. USACE Sacramento O&M Manual 128, March 1960, (HLM 1.28)]. FS Date: 1/9/2014

WS view: pipe (left), pump house/store, and concrete steps.

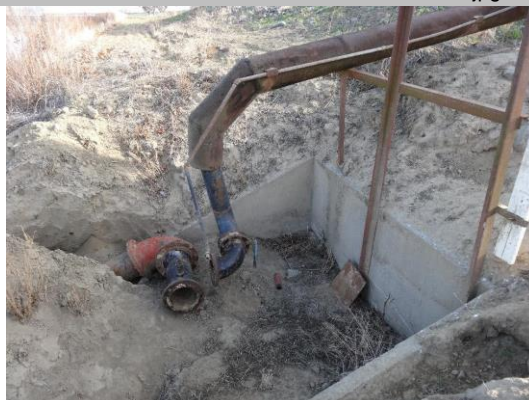
Photo 2 of 3 : UCIP_SP_2018_28903_53161.jpg

WS view: U type headwall and 8-inch pipe sleeved into 14-inch steel pipe. Pump was removed from the pipe.

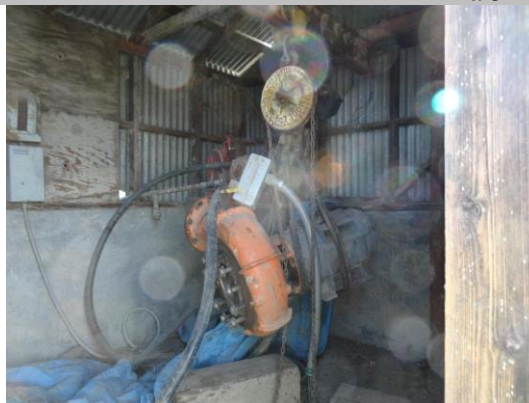
Photo 3 of 3 : UCIP_SP_2018_28903_53160.jpg

Comment Code						
Inspector Comment						
FS_ID:28903 DS_ID:20094 EP_NO: 10080 Repair Type: Non-Urgent Crossing Status: Found UCIP Comments: Pump removed from concrete pad and kept inside pump house (may be for storage purpose) on waterside.A 8-inch steel pipe inside 14-inch pipe. FIELD_STRUCT_DESC: 1 of 2: 14-inch steel irrigation discharge pipe through the levee, 5.2 feet below the crown. Pump in a corrugated metal pump house on the waterside (WS) slope. Butterfly valve on the WS. Concrete staircase on the WS slope. 1.75-inch galvanized iron water line with faucet exposed on the landside (LS) slope, 3.4 feet below the crown. 4-foot by 5.7-foot concrete distribution box at the LS toe. 1.25-inch conduit through levee, 2 feet below the crown. (14-inch steel irrigation discharge pipe through the levee and pump in a corrugated metal pump house on the WS slope authorized under Automatic Board Order (ABO) issued as Permit No. 10080, 1974 - Sebastian Yturralde). [Additional Reference(s): DWR Levee Log, 2005. USACE Sacramento O&M Manual 128, March 1960, (HLM 1.28)]. FS Date: 1/9/2014

WS view: pump removed from pipe and stored in pump house.

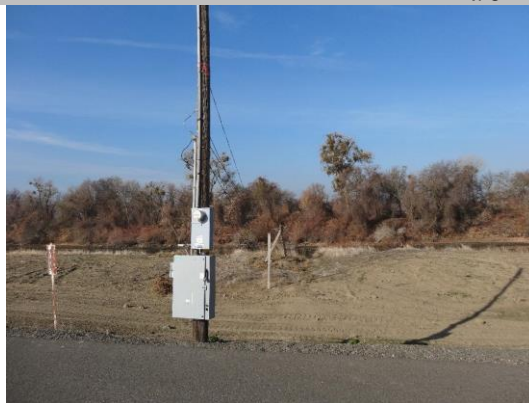
Photo 1 of 3 : UCIP_SP_2018_28204_51875.jpg

Comment Code						
Inspector Comment						
FS_ID:28204 DS_ID:20033 EP_NO: N/A Repair Type: Non-Urgent Crossing Status: Found UCIP Comments: - pump removed- erosion around pump station.- overhead electrical line. FIELD_STRUCT_DESC: 10-inch steel irrigation discharge pipe through the levee, 10 feet below the crown. Pump and gate valve on the riverbank. Service pole and switch panel on the waterside (WS) shoulder. Pipe crosses irrigation ditch and discharges into a steel distribution box in the field. (10-inch steel irrigation discharge pipe through the levee and pump on the riverbank authorized under Automatic Board Order (ABO) issued as Permit No. 10043, 1974 - Leo Giovanetti). [Additional Reference(s): DWR Levee Log, 2005. USACE Sacramento O&M Manual 128, March 1960, (HLM 1.63)]. FS Date: 1/9/2014

WS view: Service pole with control panel on levee shoulder.

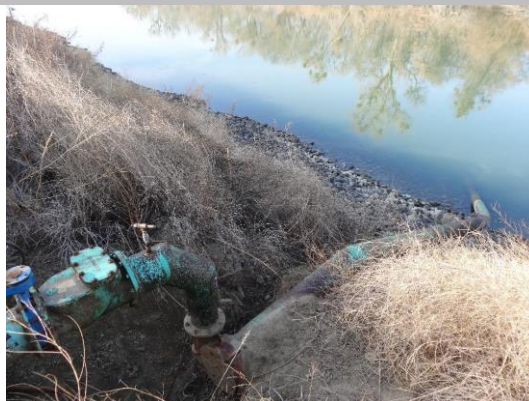
Photo 2 of 3 : UCIP_SP_2018_28204_51874.jpg

WS view: pump (removed) and inlet pipe on river bank.

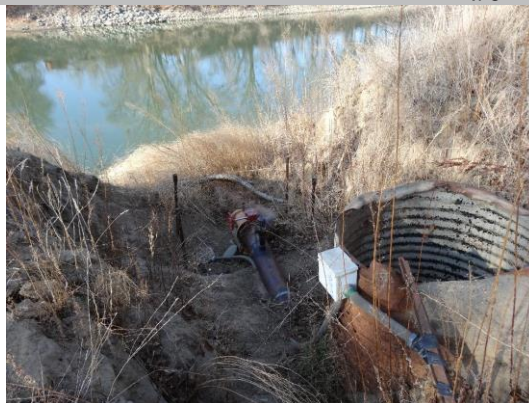
Photo 1 of 3 : UCIP_SP_2018_28263_51965.jpg

Comment Code						
Inspector Comment						
FS_ID:28263 DS_ID:20034 EP_NO: 16146 Repair Type: Non-Urgent Crossing Status: Found UCIP Comments: - pump removed- overhead powerline- pile structure abandoned- levee slope erosion due to leaky siphon breaker on landside. FIELD_STRUCT_DESC: *REPLACEMENT CROSSING* 12-inch steel irrigation discharge pipe through the levee, 12 feet below the crown. Pump mounted on the riverbank. Butterfly valve on the waterside (WS). Pump pole with one anchor on the WS slope. Pipe discharges into a 5-foot by 5-foot damaged concrete distribution box across the irrigation ditch on the landside (LS). Electrical conduit through the levee. (Cat. I - Furlan). (Abandonment-in-place of an existing pipe and replacement of approximately 70 feet of 12-inch irrigation discharge pipe authorized under Permit No. 16146, 1993 - Antonio Furlan and Joe Schreiner). [Additional Reference(s): DWR Levee Log, 2005. USACE Sacramento O&M Manual 128, March 1960, (HLM 1.96)]. FS Date: 1/9/2014

WS view: Pump (removed and plywood plated), pipe, and gate valve in CMP riser on river bank.

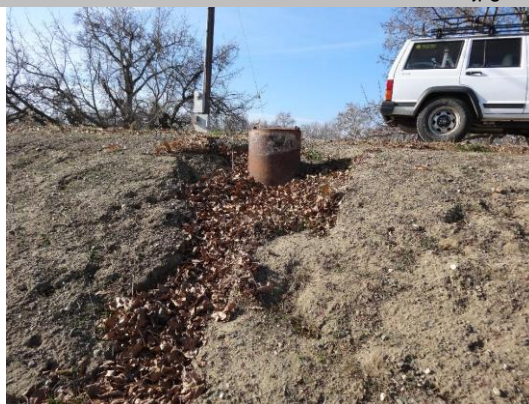
Photo 2 of 3 : UCIP_SP_2018_28263_51964.jpg

LS view: siphon breaker in CMP riser. Levee slope erosion due to leaky siphon breaker.

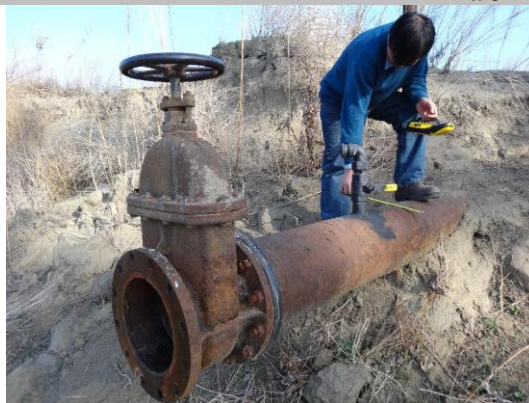
Photo 1 of 3 : UCIP_SP_2018_28264_51971.jpg

FS_ID:28264
DS_ID:20035
EP_NO: 10029
Repair Type: Non-Urgent
Crossing Status: Found
UCIP Comments: - pump removed- outlet plugged- looks abandoned. Found abandoned pipe parts on levee slope and berm.- overhead powerline
FIELD_STRUCT_DESC: *ABANDONED* 12-inch steel irrigation discharge pipe through the levee, 11 feet below the crown. Two metal cutoff walls installed. Pumps on the riverbank during irrigation season. Gate valve at the waterside (WS) toe. Pipe discharges into a 2.5-foot by 2.5-foot concrete distribution box on the landside (LS) of the irrigation ditch. (Retention of a 12-inch steel irrigation discharge pipe through the levee and pumps on the riverbank during irrigation season authorized under Automatic Board Order (ABO) issued as Permit No. 10029, 1974 - Merle Anderson). [Additional Reference(s): DWR Levee Log, 2005. USACE Sacramento O&M Manual 128, March 1960, (HLM 2.40)].
FS Date: 1/9/2014

WS view: steel pipe, gate valve, and pump (removed) on river bank.
Looks abandoned.

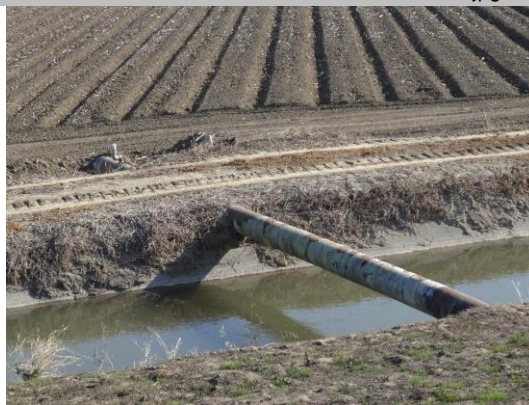
Photo 2 of 3 : UCIP_SP_2018_28264_51970.jpg

LS view: discharge pipe crossing irrigation ditch on landside.

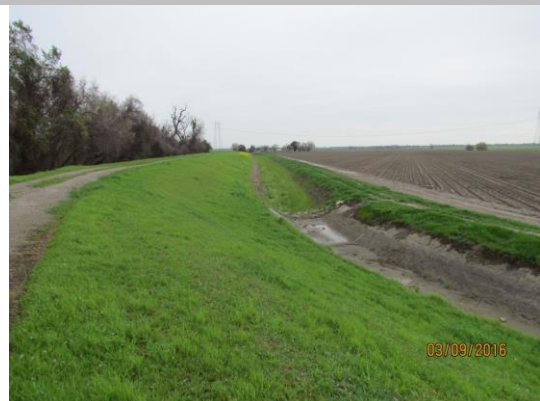
Photo 1 of 1 : SP_2018_RD1500_189_963_20180306_00083.jpg

LM Start	2.54	Rating **	M	Issue No.	963
LM End	3.68	Issue Type +	En	Location *	LS
Category	Earthen Levee			GPS Latitude/Longitude	
				Start	End
Item	Encroachments			38.785351 °	38.797128 °
				-121.689075 °	-121.691047 °
DWR ID	DWR_RD1500_01_s_2012_963				
Comment Code					
DT : Ditch					
Inspector Comment

View of the ditch at the toe of the landward side of the levee looking upstream. Spring 2016.

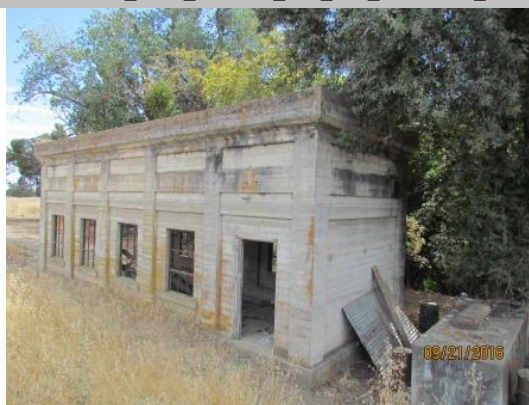
Photo 1 of 1 : SP_2018_RD1500_189_131_20180306_00069.jpg

LM Start	3.69	Rating **	M	Issue No.	131
LM End	3.69	Issue Type +	En	Location *	WS
Category	Earthen Levee			GPS Latitude/Longitude	
				Start	End
Item	Encroachments			38.797152 °	38.797152 °
				-121.691238 °	-121.691238 °
DWR ID	DWR_RD1500_01_f_2016_131				
Comment Code					
BU : Building					
Inspector Comment					
Abandoned building

Abandoned building at waterward toe of the levee. Fall 2016.

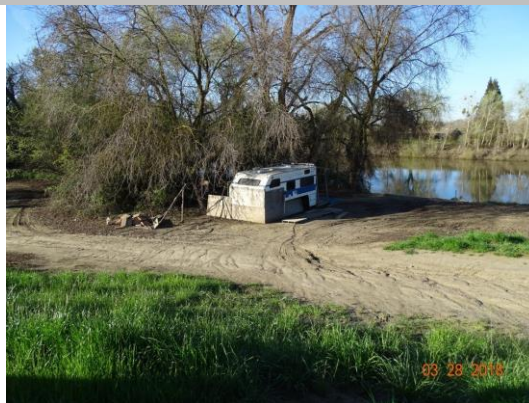
Photo 1 of 1 : SP_2018_RD1500_189_128_20180329_00239.jpg

LM Start	3.94	Rating **	M	Issue No.	128
LM End	3.94	Issue Type +	En	Location *	WS
Category	Earthen Levee			GPS Latitude/Longitude	
				Start	End
Item	Encroachments			38.797541 °	38.797541 °
				-121.695674 °	-121.695674 °
DWR ID	DWR_RD1500_01_s_2018_128				
Comment Code					
BU : Building					
Inspector Comment					
Converted trailer to permanent residence on waterside berm.

View of trailer on the waterside berm. Spring 2018.

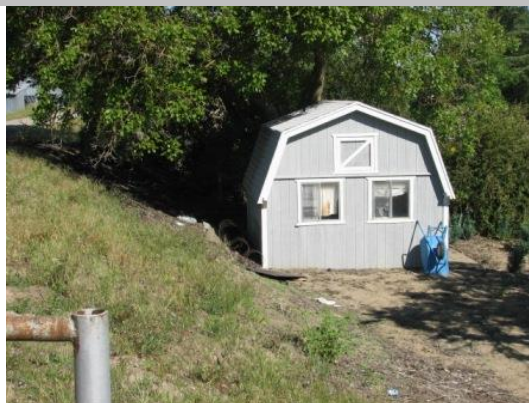
Photo 1 of 2 : SP_2018_RD1500_189_7_20180306_00007.jpg

LM Start	3.94	Rating **	U	Issue No.	7
LM End	3.94	Issue Type +	En	Location *	LS
Category	Earthen Levee			GPS Latitude/Longitude	
				Start	End
Item	Encroachments			38.797573 °	38.797573 °
				-121.695727 °	-121.695727 °
DWR ID	DWR_RD1500_01_s_2012_7				
Comment Code					
BU : Building					
Inspector Comment

A small building is encroaching into the landside levee toe.

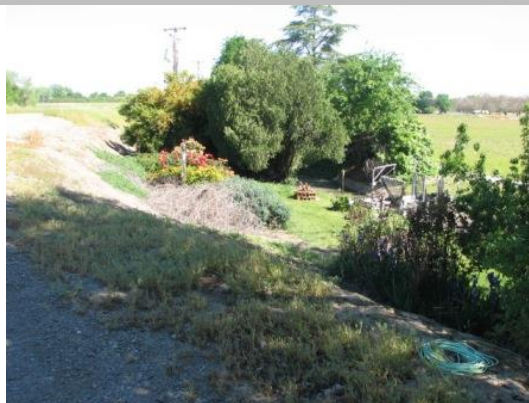
Photo 1 of 2 : SP_2018_RD1500_189_8_20180306_00009.jpg

LM Start	3.97	Rating **	A/W	Issue No.	8
LM End	3.97	Issue Type +	En	Location *	LS
Category	Earthen Levee			GPS Latitude/Longitude	
				Start	End
Item	Vegetation			38.797838 °	38.797838 °
				-121.696046 °	-121.696046 °
DWR ID	DWR_RD1500_01_s_2012_8				
Comment Code					
V6 : Landscaping					
Inspector Comment					
Most of the vegetation has been removed. There appears to be new landscaping at the toe of the levee.

The landscape is planted into the encroachment zone within 15' of the toe.

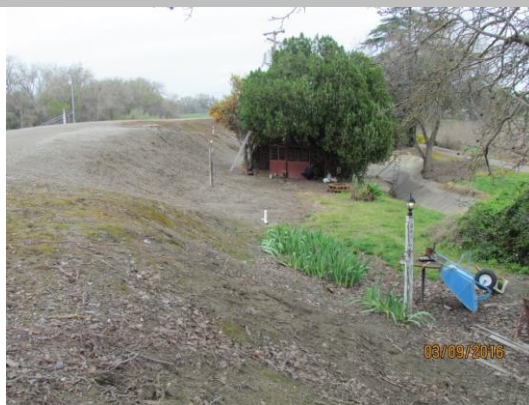
Photo 2 of 2 : SP_2018_RD1500_189_8_20180306_00010.jpg

View of the landscaping on the landward side of the levee looking upstream. Spring 2016.

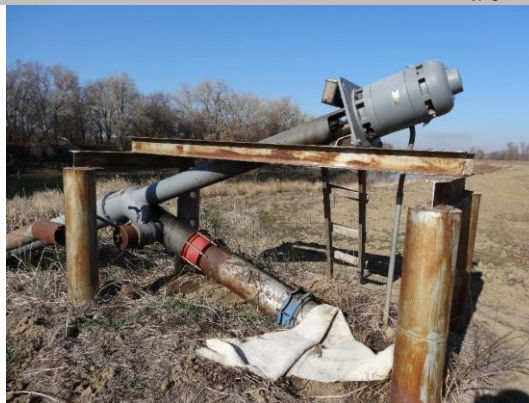
Photo 1 of 3 : UCIP_SP_2018_28272_52012.jpg

Comment Code						
Inspector Comment						
FS_ID:28272						
DS_ID:20037						
EP_NO: 3638						
Repair Type: Non-Urgent						
Crossing Status: Found						
UCIP Comments: - No protection for pressure breaker.						
FIELD_STRUCT_DESC: 12-inch steel irrigation discharge pipe through the levee, 2.4 feet below the crown. Slant pump on the berm. Siphon breaker on the landside (LS) slope. Service pole at the LS toe. Pipe discharges into a 36-inch concrete standpipe on the LS. (Installation, maintenance, and operation of an inclined pump and an existing pipe to remain through the levee authorized under Permit No. 3638, 1961 - James F. Waters). [Additional Reference(s): DWR Levee Log, 2005. USACE Sacramento O&M Manual 128, March 1960, (HLM 4.04)].						
FS Date: 1/9/2014

WS view: slant pump on steel frame on levee berm.

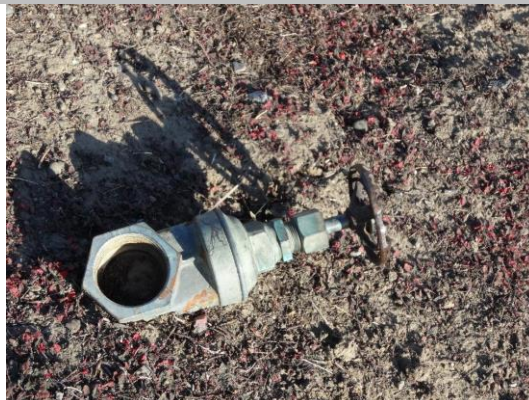
Photo 2 of 3 : UCIP_SP_2018_28272_52011.jpg

LS view: pressure breaker without protection on levee slope.

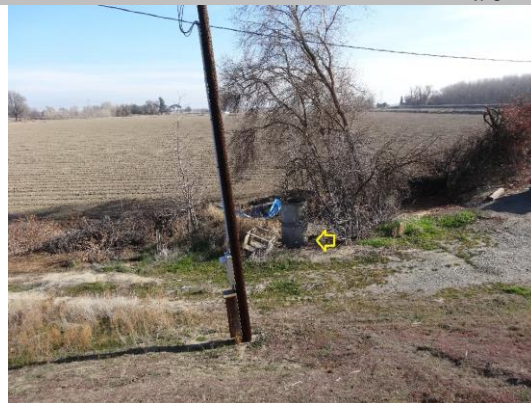
Photo 3 of 3 : UCIP_SP_2018_28272_52013.jpg

Comment Code						
Inspector Comment						
FS_ID:28272 DS_ID:20037 EP_NO: 3638 Repair Type: Non-Urgent Crossing Status: Found UCIP Comments: - No protection for pressure breaker. FIELD_STRUCT_DESC: 12-inch steel irrigation discharge pipe through the levee, 2.4 feet below the crown. Slant pump on the berm. Siphon breaker on the landside (LS) slope. Service pole at the LS toe. Pipe discharges into a 36-inch concrete standpipe on the LS. (Installation, maintenance, and operation of an inclined pump and an existing pipe to remain through the levee authorized under Permit No. 3638, 1961 - James F. Waters). [Additional Reference(s): DWR Levee Log, 2005. USACE Sacramento O&M Manual 128, March 1960, (HLM 4.04)]. FS Date: 1/9/2014

LS view: power pole and concrete standpipe on levee toe.

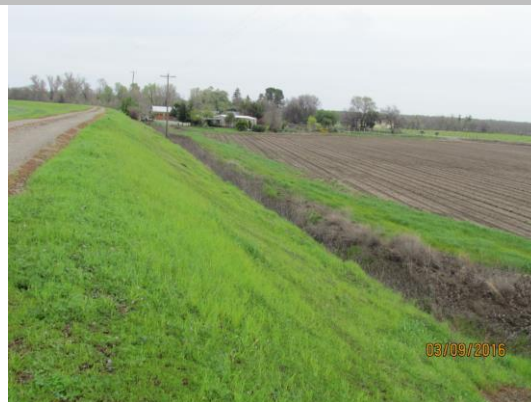
Photo 1 of 1 : SP_2018_RD1500_189_54_20180306_00037.jpg

LM Start	4.02	Rating **	M	Issue No.	54
LM End	4.12	Issue Type +	En	Location *	LS
Category	Earthen Levee			GPS Latitude/Longitude	
				Start	End
Item	Encroachments			38.798526 °	38.800063 °
				-121.696326 °	-121.696622 °
DWR ID	DWR_RD1500_01_s_2012_54				
Comment Code					
DT : Ditch					
Inspector Comment					
Ditch runs along the toe of the levee.

View of the ditch on the landward side of the levee looking upstream. Spring 2016.

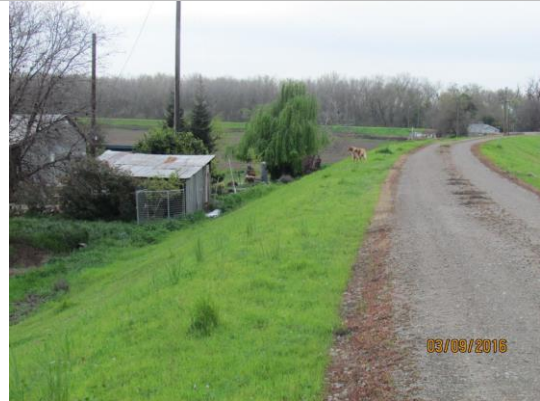
Photo 1 of 1 : SP_2018_RD1500_189_11_20180306_00012.jpg

LM Start	4.16	Rating **	M	Issue No.	11
LM End	4.16	Issue Type +	En	Location *	LS
Category	Earthen Levee			GPS Latitude/Longitude	
				Start	End
Item	Encroachments			38.800548 °	38.800548 °
				-121.696751 °	-121.696751 °
DWR ID	DWR_RD1500_01_s_2012_11				
Comment Code					
BU : Building					
Inspector Comment

View of the equipment shed on the landward side of the levee looking downstream. Spring 2016.

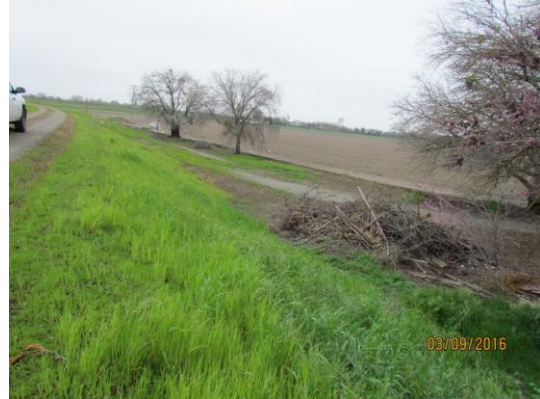
Photo 1 of 1 : SP_2018_RD1500_189_142_20180306_00074.jpg

LM Start	4.61	Rating **	M	Issue No.	142
LM End	4.61	Issue Type +	En	Location *	LS
Category	Earthen Levee			GPS Latitude/Longitude	
				Start	End
Item	Encroachments			38.803509 °	38.803509 °
				-121.703046 °	-121.703046 °
DWR ID	DWR_RD1500_01_s_2016_142				
Comment Code					
PR : Prunings					
Inspector Comment

View of the pruning pile on the landward side of the levee looking upstream. Spring 2016.

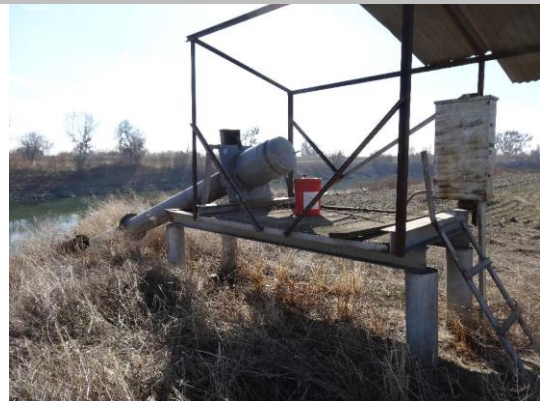
Photo 1 of 3 : UCIP_SP_2018_28912_53181.jpg

Comment Code					
Inspector Comment					
FS_ID:28912 DS_ID:20040 EP_NO: 5031 Repair Type: Non-Urgent Crossing Status: Found UCIP Comments: New butterfly valve in CMP riser on waterside slope. New pipe and pump.Needs cleaning and clearing of siphon breaker in CMP on landside.An abandoned 5x5 foot concrete distribution box on landside. Abandoned pipe found on both sides of the levee. FIELD_STRUCT_DESC: 12-inch steel irrigation discharge pipe through the levee at a slight angle, 4.2 feet below the crown. 2-inch conduit through the levee, 2 feet below the crown. Slant pump on a steel platform on the berm. (Slant pump authorized under Permit No. 5031, 1965 - Gladys Johnston and Helen Dixon). Pipe discharges into an irrigation ditch and an abandoned 5-foot by 5-foot concrete distribution box on the landside. (Pipe originally installed in 1950. 12-inch centrifugal irrigation pump and 14-inch, 12-gage welded steel pipe through the levee authorized under Permit No. 1466, 1950 - Estate of Caroline L. Knox. Pipe reinstalled by USACE in 1958). [Additional Reference(s): DWR Levee Log, 2005. USACE Sacramento O&M Manual 128, March 1960, (HLM 4.71)]. FS Date: 1/9/2014

WS view: slant pump and switch panel in shed on levee berm.

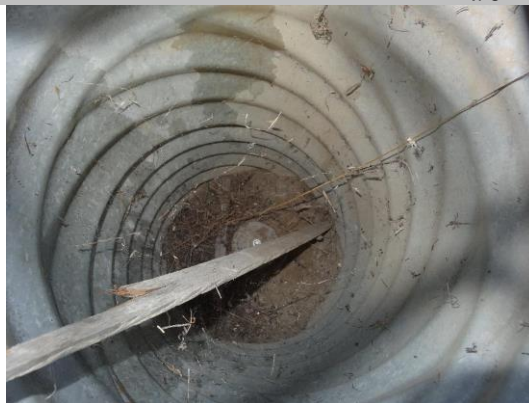
Photo 2 of 3 : UCIP_SP_2018_28912_53180.jpg

Item	DWR UCIP Field Study		38.803025 °	38.803025 °								
			-121.704091 °	-121.704091 °								
DWR ID												
Comment Code												
Inspector Comment												
FS_ID:28912 DS_ID:20040 EP_NO: 5031 Repair Type: Non-Urgent Crossing Status: Found UCIP Comments: New butterfly valve in CMP riser on waterside slope. New pipe and pump. Needs cleaning and clearing of siphon breaker in CMP on landside. An abandoned 5x5 foot concrete distribution box on landside. Abandoned pipe found on both sides of the levee. FIELD_STRUCT_DESC: 12-inch steel irrigation discharge pipe through the levee at a slight angle, 4.2 feet below the crown. 2-inch conduit through the levee, 2 feet below the crown. Slant pump on a steel platform on the berm. (Slant pump authorized under Permit No. 5031, 1965 - Gladys Johnston and Helen Dixon). Pipe discharges into an irrigation ditch and an abandoned 5-foot by 5-foot concrete distribution box on the landside. (Pipe originally installed in 1950. 12-inch centrifugal irrigation pump and 14-inch, 12-gage welded steel pipe through the levee authorized under Permit No. 1466, 1950 - Estate of Caroline L. Knox. Pipe reinstalled by USACE in 1958). [Additional Reference(s): DWR Levee Log, 2005. USACE Sacramento O&M Manual 128, March 1960, (HLM 4.71)]. FS Date: 1/9/2014

LS view: obstructed siphon breaker in CMP riser.

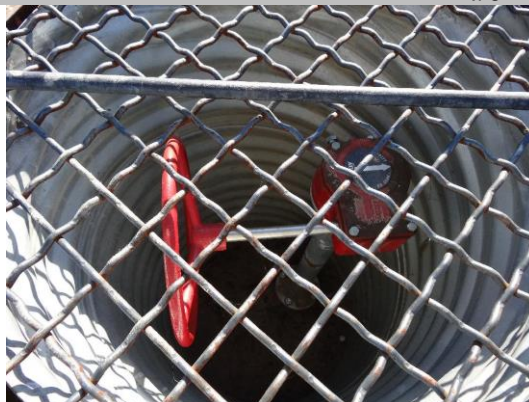
Photo 3 of 3 : UCIP_SP_2018_28912_53179.jpg

WS view: new butterfly valve in CMP on levee shoulder.

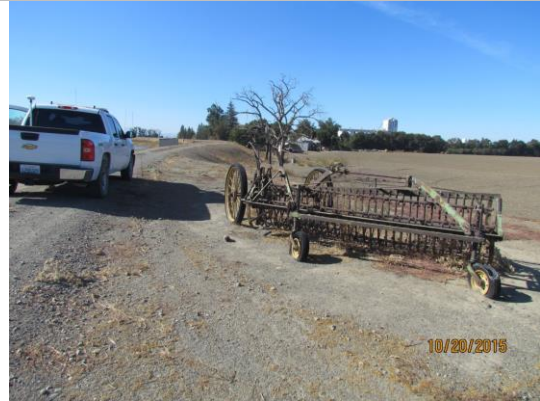
Photo 1 of 1 : SP_2018_RD1500_189_108_20180306_00055.jpg

LM Start	5.14	Rating **	M	Issue No.	108
LM End	5.14	Issue Type +	En	Location *	LS
Category	Earthen Levee			GPS Latitude/Longitude	
				Start	End
Item	Encroachments			38.801962 °	38.801962 °
				-121.712118 °	-121.712118 °
DWR ID	DWR_RD1500_01_f_2015_108				
Comment Code					
EQ : Equipment					
Inspector Comment

View of the equipment on the landward side of the levee looking upstream. Fall 2015.

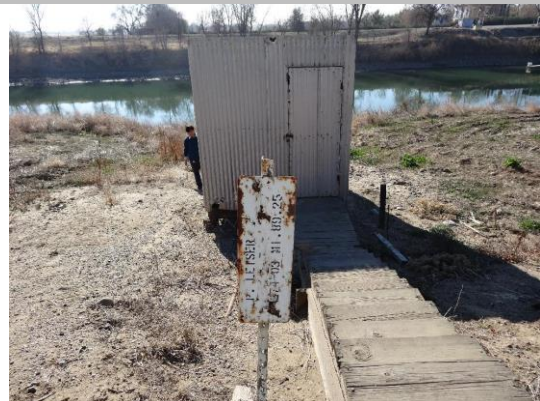
Photo 1 of 3 : UCIP_SP_2018_28913_53184.jpg

Comment Code						
Inspector Comment						
FS_ID:28913 DS_ID:20041 EP_NO: 10056 Repair Type: Non-Urgent Crossing Status: Found UCIP Comments: Depression on landside levee slope around siphon breaker due to leakage.Siphon breaker needs protection. FIELD_STRUCT_DESC: 18-inch steel irrigation discharge pipe through the levee, 4 feet below the crown. 1.5-inch conduit through the levee, 20 feet below the crown. Slant pump in a corrugated metal pump house on the waterside (WS). Wooden steps on the WS slope. Siphon breaker on the landside (LS) slope. 5-foot by 5-foot concrete distribution box at the LS toe. (18-inch steel irrigation discharge pipe and all other elements of this irrigation structure retained under Automatic Board Order (ABO) issued as Permit No. 10056, 1974 - Philip Leiser). [Additional Reference(s): DWR Levee Log, 2005. USACE Sacramento O&M Manual 128, March 1960, (HLM 5.23)]. FS Date: 1/9/2014

WS view: wooden steps to pump house on levee berm.

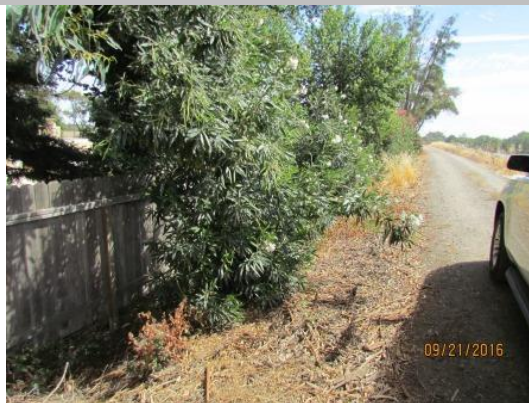
Photo 1 of 1 : SP_2018_RD1500_189_125_20180306_00068.jpg

LM Start	5.32	Rating **	U	Issue No.	125
LM End	5.35	Issue Type +	En	Location *	LS
Category	Earthen Levee			GPS Latitude/Longitude	
				Start	End
Item	Encroachments			38.803181 °	38.803344 °
				-121.715141 °	-121.715616 °
DWR ID	DWR_RD1500_01_f_2016_125				
Comment Code					
FE : Fence					
Inspector Comment

View of fence and vegetation on LS slope. Fall 2016.

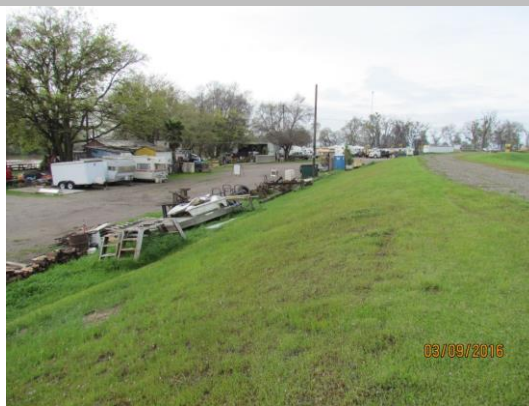
Photo 1 of 1 : SP_2018_RD1500_189_52_20180306_00036.jpg

LM Start	5.61	Rating **	M	Issue No.	52
LM End	5.69	Issue Type +	En	Location *	WS
Category	Earthen Levee			GPS Latitude/Longitude	
				Start	End
Item	Encroachments			38.803067 °	38.803238 °
				-121.720270 °	-121.721847 °
DWR ID	DWR_RD1500_01_s_2012_52				
Comment Code					
EQ : Equipment					
Inspector Comment					
Sting Rayz Beach Boardwalk Marina on the waterside berm should move equipment stored on levee toe away from levee.

View of equipment on waterside levee toe looking upstream. Spring 2016.

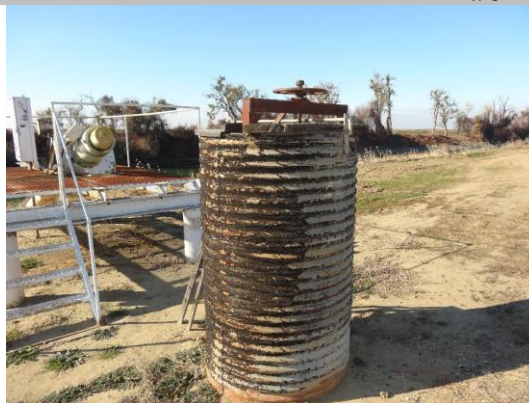
Photo 1 of 2 : UCIP_SP_2018_28286_52059.jpg

Comment Code					
Inspector Comment					
FS_ID:28286 DS_ID:20044 EP_NO: 10074 Repair Type: Non-Urgent Crossing Status: Found UCIP Comments: Not found- 36-inch concrete standpipe on landside. 2-inch conduit through the levee.Pipe description does not match with field observaion. It needs review and more info from LMA.A capped pipe, air vent, and butterfly valve found on landside toe. But, it is not clear whether these belongs to this crossing. FIELD_STRUCT_DESC: 30-inch steel irrigation discharge pipe and electrical conduit through the levee, 13 feet below the crown. Slide gate in a 42-inch corrugated metal pipe (CMP) riser on the berm. Slant pump on steel pump platform on the berm. Installed by USACE in 1959. (30-inch steel irrigation discharge pipe and all other appurtenances retained under Automatic Board Order (ABO) issued as Permit No. 10074, 1974 - T. I. and T. Company). [Additional Reference(s): DWR Levee Log, 2005. USACE Sacramento O&M Manual 128, March 1960, (HLM 6.53)]. FS Date: 1/9/2014

WS view: CMP riser with slide gate and slant pump on steel platform on levee berm.

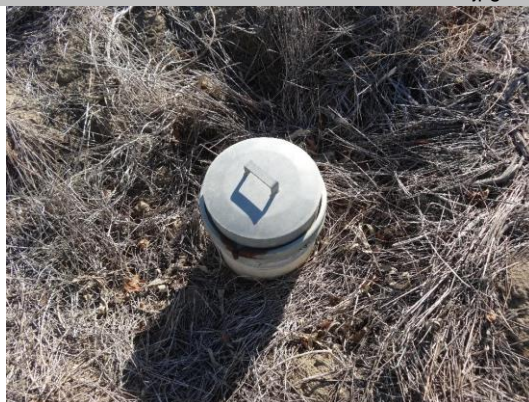
Photo 2 of 2 : UCIP_SP_2018_28286_52058.jpg

LS view: a capped pipe on levee toe. It is not clear whether this pipe is connected to the CMP riser on waterside.

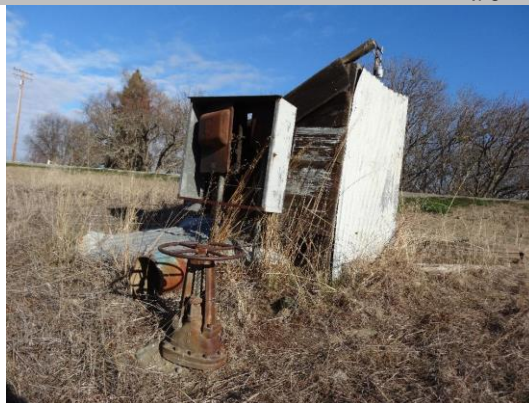
Photo 1 of 3 : UCIP_SP_2018_28923_53202.jpg

Comment Code						
Inspector Comment						
FS_ID:28923 DS_ID:20047 EP_NO: 10048 Repair Type: Non-Urgent Crossing Status: Found UCIP Comments: An abandoned pipe. Highly deteriorated pipe on river bank.Needs proper abandonment.Not found- Siphon breaker at landward levee toe. FIELD_STRUCT_DESC: *ABANDONED* 10-inch steel irrigation discharge pipe and a 1-inch conduit through the levee, 4.5 feet below the crown. Pump in a metal shed on the riverbank. Gate valve on the waterside (WS) end. Service pole and 24-inch concrete standpipe at the landside (LS) toe. Installed by USACE in 1958. (10-inch steel irrigation discharge pipe through the levee and all other appurtenances retained under Automatic Board Order (ABO) issued as Permit No. 10048, 1974 - Virgil J. King) [Additional Reference(s): DWR Levee Log, 2005. USACE Sacramento O&M Manual 128, March 1960, (HLM 7.22)]. FS Date: 1/9/2014

WS view: dilapidated and abandoned CM pump house on berm. Pipe and gate valve also on berm.

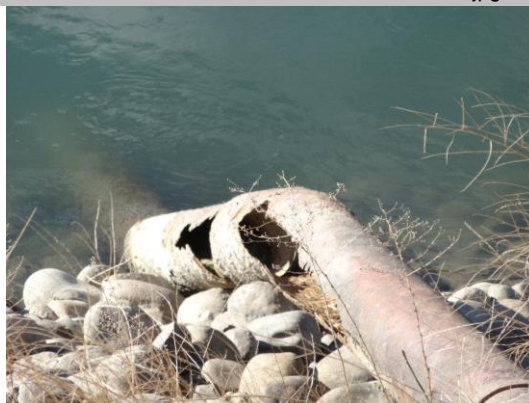
Photo 2 of 3 : UCIP_SP_2018_28923_53201.jpg

WS view: deteriorated and abandoned steel pipe on river bank.

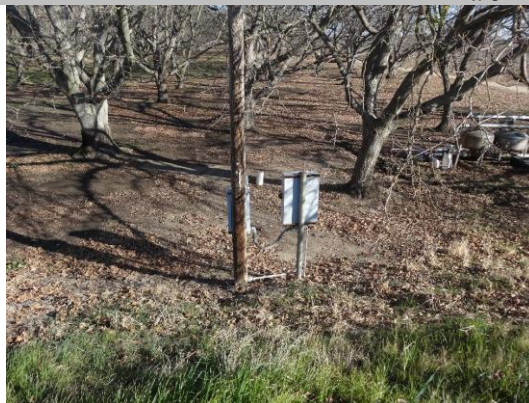
Photo 3 of 3 : UCIP_SP_2018_28923_53200.jpg

Comment Code						
Inspector Comment						
FS_ID:28923 DS_ID:20047 EP_NO: 10048 Repair Type: Non-Urgent Crossing Status: Found UCIP Comments: An abandoned pipe. Highly deteriorated pipe on river bank.Needs proper abandonment.Not found- Siphon breaker at landward levee toe. FIELD_STRUCT_DESC: *ABANDONED* 10-inch steel irrigation discharge pipe and a 1-inch conduit through the levee, 4.5 feet below the crown. Pump in a metal shed on the riverbank. Gate valve on the waterside (WS) end. Service pole and 24-inch concrete standpipe at the landside (LS) toe. Installed by USACE in 1958. (10-inch steel irrigation discharge pipe through the levee and all other appurtenances retained under Automatic Board Order (ABO) issued as Permit No. 10048, 1974 - Virgil J. King) [Additional Reference(s): DWR Levee Log, 2005. USACE Sacramento O&M Manual 128, March 1960, (HLM 7.22)]. FS Date: 1/9/2014

LS view: service pole and switch board on levee toe. No other appurtenances found on landside.

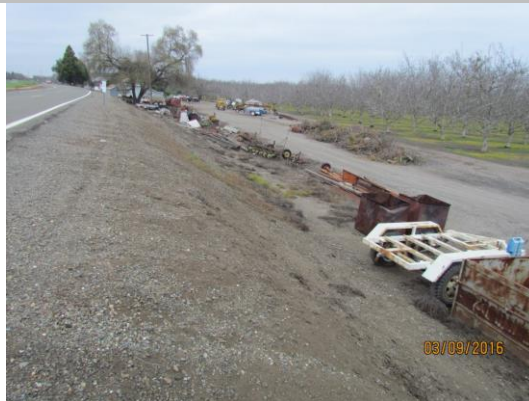
Photo 1 of 1 : SP_2018_RD1500_189_16_20180306_00015.jpg

LM Start	7.49	Rating **	M	Issue No.	16
LM End	7.49	Issue Type +	En	Location *	LS
Category	Earthen Levee			GPS Latitude/Longitude	
				Start	End
Item	Encroachments			38.828944 °	38.828944 °
				-121.724329 °	-121.724329 °
DWR ID	DWR_RD1500_01_f_2017_16				
Comment Code					
EQ : Equipment					
Inspector Comment

View of the equipment along the levee toe on the landward side of the levee looking upstream. Spring 2016.

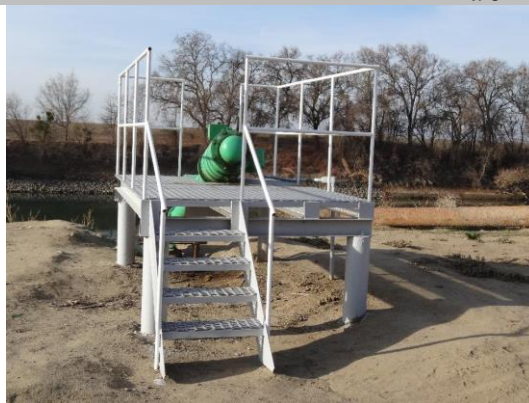
Photo 1 of 3 : UCIP_SP_2018_50199_53204.jpg

Comment Code						
Inspector Comment						
FS_ID:50199 DS_ID:20049 EP_NO: 8147 Repair Type: Non-Urgent Crossing Status: Found UCIP Comments: 08/29/2016: New pumps installed at LS toe ditch, could not find permit for this work. No signs of leakage or excessive vegetation growth in alignment with the pipe. Riser silted in; recommend installing a lid. Crossing has been downgraded from Urgent to Non-Urgent. (K. Fazel - UCIP)01/10/2014:Not found- slide gate in 48-inch corrugated metal riser at waterside toe.Repair works under way. Contact LMA for repair works information.Sign of leaky pipe and siphon breaker. This needs detailed investigation. (P. Amatya - DWR) FIELD_STRUCT_DESC: 12-inch steel irrigation discharge pipe through the levee, 4.8 feet below the crown. Slant pump mounted on a steel structure at the riverbank. 4-foot by 4-foot concrete distribution box at the landside (LS) toe with newly installed pumps with shutoff valves. (Replacement of a discharge pipe through the levee with a new 12-inch steel discharge pipe authorized under Permit No. 8147, 1972 - J. A. Driver). [Additional Reference(s): DWR Levee Log, 2005. USACE Sacramento O&M Manual 128, March 1960, (HLM 7.79)]. FS Date: 8/29/2016

WS view: slant pump on steel platform on end of berm.

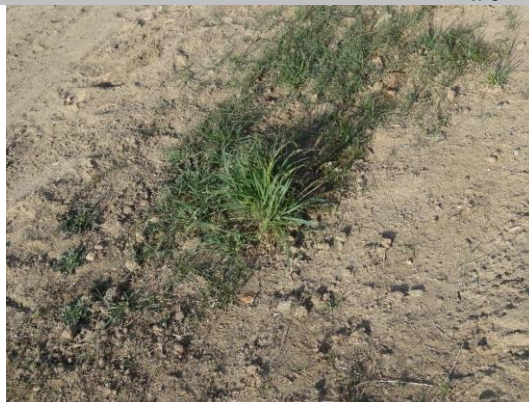
Photo 2 of 3 : UCIP_SP_2018_50199_53203.jpg

WS view: sign of leakage- excessive vegetation on levee slope.

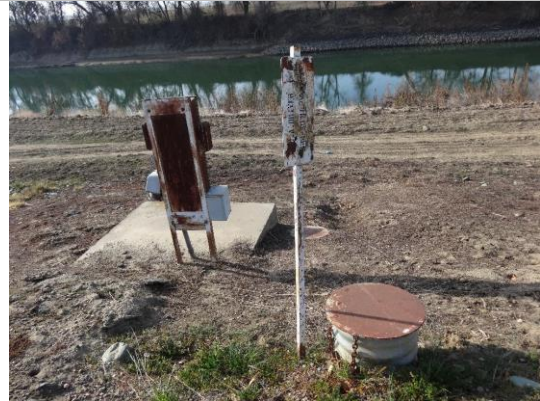
Photo 1 of 3 : UCIP_SP_2018_28323_52125.jpg

FS_ID:28323
DS_ID:20051
EP_NO: 13882
Repair Type: Non-Urgent
Crossing Status: Found
UCIP Comments: Power pole on landside. 2-inch conduit through the levee. Service box on waterside. Concrete pad on waterside. Not found- Concrete distribution box on landward side; not found- gate valve on waterside. Need proper abandonment. Pipe visible on river bank, waterside levee slope and landside field.
FIELD_STRUCT_DESC: *ABANDONED* 6-inch steel irrigation discharge pipe through the levee, 4.9 feet below the crown. 12-inch steel irrigation discharge pipe through the levee, 5 feet below the crown. 1.5-inch electrical conduit through the levee, 4 feet below the crown. Pump at the riverbank. Pump switch and gate valve on the waterside (WS) slope. Meter pole at the landside (LS) toe. Concrete distribution box on the LS. Installed by USACE in 1959. (6-inch steel irrigation discharge pipe through the levee and all other appurtenances retained under Automatic Board Order (ABO) issued as Permit No. 10062, 1974 - Pauline Moroni. Installation of a 12-inch steel pipe through the levee authorized under Permit No. 13882, 1984 - Ted A. Moroni).

WS view: CMP with air vent (right), concrete pad (left), and switch panel (left) on levee slope.

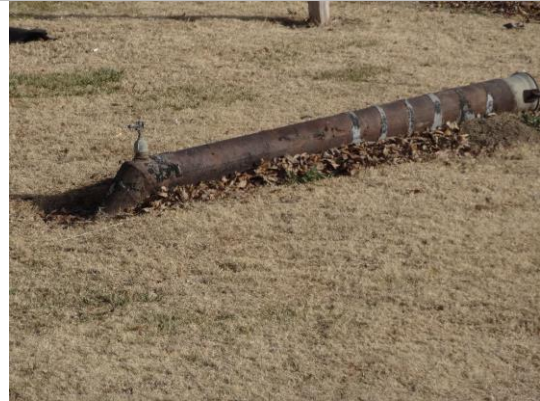
Photo 3 of 3 : UCIP_SP_2018_28323_52123.jpg

Comment Code						
Inspector Comment						
FS_ID:28323 DS_ID:20051 EP_NO: 13882 Repair Type: Non-Urgent Crossing Status: Found UCIP Comments: Power pole on landside. 2-inch conduit through the levee. Service box on waterside. Concrete pad on waterside. Not found- Concrete distribution box on landward side; not found- gate valve on waterside. Need proper abandonment. Pipe visible on river bank, waterside levee slope and landside field. FIELD_STRUCT_DESC: *ABANDONED* 6-inch steel irrigation discharge pipe through the levee, 4.9 feet below the crown. 12-inch steel irrigation discharge pipe through the levee, 5 feet below the crown. 1.5-inch electrical conduit through the levee, 4 feet below the crown. Pump at the riverbank. Pump switch and gate valve on the waterside (WS) slope. Meter pole at the landside (LS) toe. Concrete distribution box on the LS. Installed by USACE in 1959. (6-inch steel irrigation discharge pipe through the levee and all other appurtenances retained under Automatic Board Order (ABO) issued as Permit No. 10062, 1974 - Pauline Moroni. Installation of a 12-inch steel pipe through the levee authorized under Permit No. 13882, 1984 - Ted A. Moroni). [Additional Reference(s): DWR Levee Log, 2005. USACE Sacramento O&M Manual 128, March 1960, (HLM 8.04)]. FS Date: 1/10/2014

LS view: outlet steel pipe across the residential road off the levee toe on field.

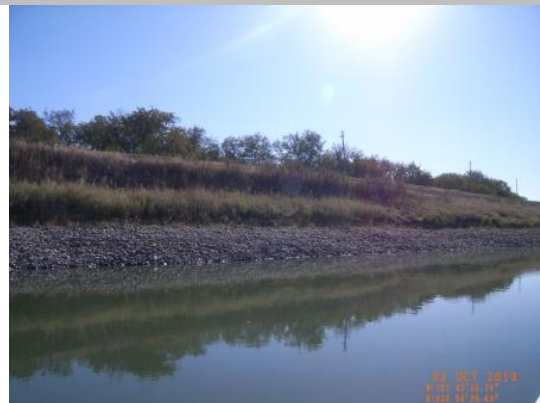
Photo 1 of 1 : SP_2018_RD1500_189_3_20180306_00003.jpg

LM Start	8.33	Rating **	A/W	Issue No.	3
LM End	8.47	Issue Type +	Ma	Location *	WS
Category	Supplemental			GPS Latitude/Longitude	
				Start	End
Item	2015 USACE Erosion Survey, DRAFT			38.839546 °	38.840347 °
				-121.729591 °	-121.726857 °
DWR ID	DWR_RD1500_01_s_2016_3				
Comment Code					
Inspector Comment					
1997 - Damage to cobble revetment on top left bank and toe damage. 2004 - Site is pretty minor. 2010 - Cobbles continue to deteriorate. 2011 - Minor new erosion at the toe. 2013 - Might be able to shorten due to deposition. 2015: Site shortened, downstream end has plenty of berm and deposited material, well vegetated. [2015 Site ID: SAC_92-8_L]

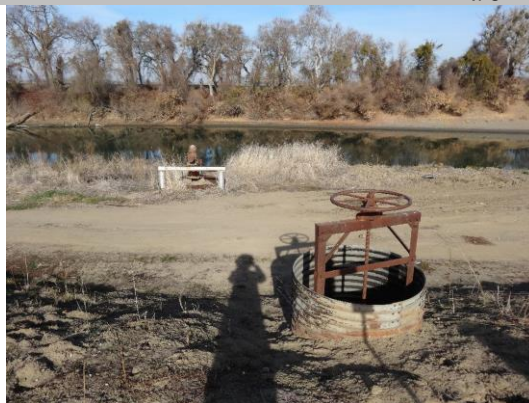
Photo 1 of 3 : UCIP_SP_2018_28324_52131.jpg

Comment Code						
Inspector Comment						
FS_ID:28324 DS_ID:20053 EP_NO: 10064 Repair Type: Non-Urgent Crossing Status: Found UCIP Comments: Looks abandoned as service pole not found.May need proper abandonment. FIELD_STRUCT_DESC: 24-inch by 24-inch concrete box irrigation discharge culvert through the levee, 13 feet below the crown. Two concrete cutoff walls. Pump on a 6-foot-diameter concrete pump well on the berm. Slide gate in a 42-inch corrugated metal pipe (CMP) riser on the waterside (WS) slope. 4.5-foot by 6-foot concrete distribution box at the landside (LS) toe. Installed by Reclamation District No. 1500 in 1920. Improvements made by USACE in 1955. (24-inch by 24-inch concrete box irrigation discharge culvert through the levee and all other appurtenances retained under Automatic Board Order (ABO) issued as Permit No. 10064, 1974 - Paul Donald Nix). [Additional Reference(s): DWR Levee Log, 2005. USACE Sacramento O&M Manual 128, March 1960, (HLM 8.44), 36-inch pipe referenced]. FS Date: 1/10/2014

WS view: slide gate in CMP riser on levee slope. Looks abandoned.

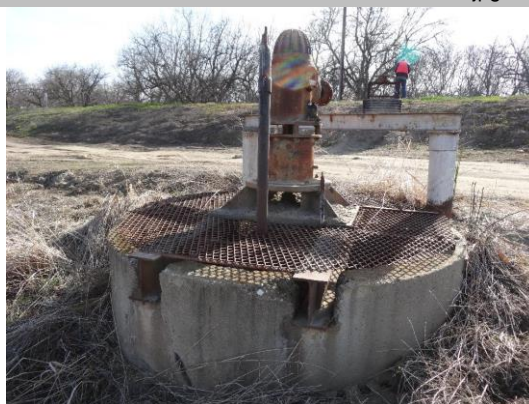
Photo 2 of 3 : UCIP_SP_2018_28324_52130.jpg

WS view: vertical pump on concrete sump on levee berm. Looks abandoned.

Comment Code						
Inspector Comment						
FS_ID:28324 DS_ID:20053 EP_NO: 10064 Repair Type: Non-Urgent Crossing Status: Found UCIP Comments: Looks abandoned as service pole not found.May need proper abandonment. FIELD_STRUCT_DESC: 24-inch by 24-inch concrete box irrigation discharge culvert through the levee, 13 feet below the crown. Two concrete cutoff walls. Pump on a 6-foot-diameter concrete pump well on the berm. Slide gate in a 42-inch corrugated metal pipe (CMP) riser on the waterside (WS) slope. 4.5-foot by 6-foot concrete distribution box at the landside (LS) toe. Installed by Reclamation District No. 1500 in 1920. Improvements made by USACE in 1955. (24-inch by 24-inch concrete box irrigation discharge culvert through the levee and all other appurtenances retained under Automatic Board Order (ABO) issued as Permit No. 10064, 1974 - Paul Donald Nix). [Additional Reference(s): DWR Levee Log, 2005. USACE Sacramento O&M Manual 128, March 1960, (HLM 8.44), 36-inch pipe referenced]. FS Date: 1/10/2014

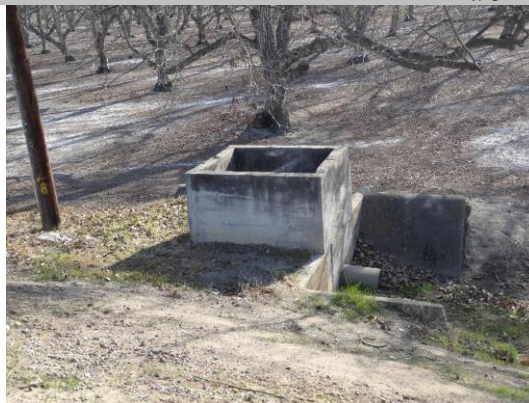
Photo 3 of 3 : UCIP_SP_2018_28324_52129.jpg

LS view: concrete distribution box on levee toe.

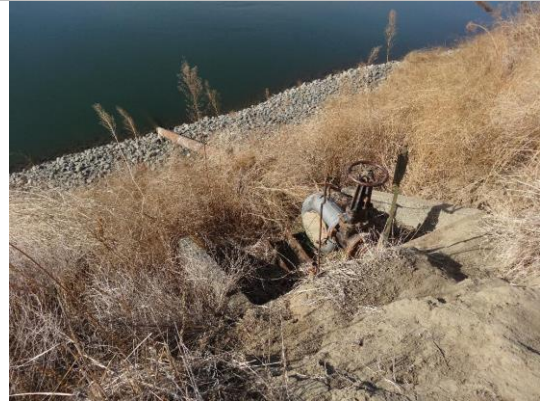
Photo 1 of 3 : UCIP_SP_2018_28343_52145.jpg

WS view: U type concrete headwall, pipe, and pump on river bank.

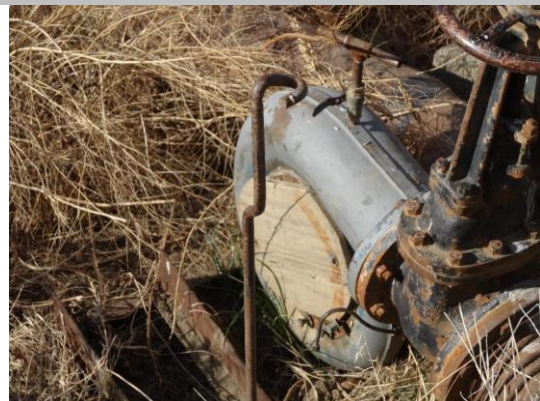
Photo 2 of 3 : UCIP_SP_2018_28343_52144.jpg

WS view: pipe, pump (removed and capped with plywood), and gate valve on river bank.

Comment Code						
Inspector Comment						
FS_ID:28343 DS_ID:20054 EP_NO: 5518 Repair Type: Non-Urgent Crossing Status: Found UCIP Comments: Not found- siphon breaker on landward shoulder. Pump removed. FIELD_STRUCT_DESC: 10-inch steel irrigation discharge pipe through the levee, 2.5 feet below the crown. Corrugated metal cutoff wall. Pump on concrete platform on the riverbank. Siphon breaker on the landside (LS) shoulder. 1-inch conduit installed in joint trench. Meter pole at the LS toe. Pipe discharges into a 4-foot by 4-foot concrete distribution box on the LS. (Installation of a 10-inch irrigation discharge pipe through the levee with a pump and a discharge box authorized under Permit No. 5518, 1966 - Irving E. Bundock, [RM 92.9]). FS Date: 1/10/2014

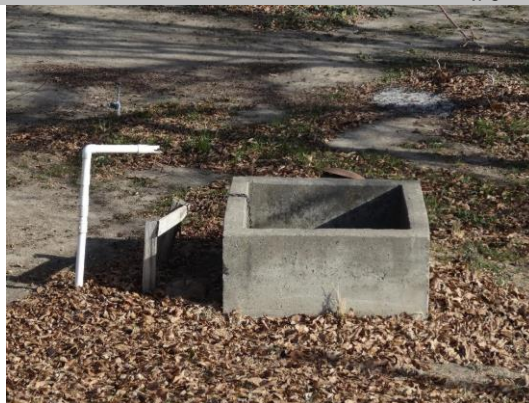
Photo 3 of 3 : UCIP_SP_2018_28343_52143.jpg

LS view: concrete distribution box on landside toe.

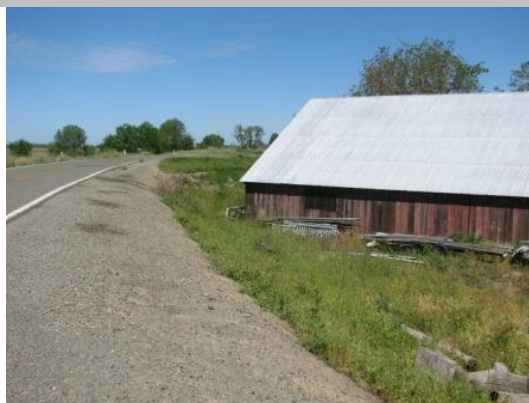
Photo 1 of 1 : SP_2018_RD1500_189_18_20180306_00016.jpg

LM Start	8.72	Rating **	M	Issue No.	18
LM End	8.72	Issue Type +	En	Location *	LS
Category	Earthen Levee			GPS Latitude/Longitude	
				Start	End
Item	Encroachments			38.842673 °	38.842673 °
				-121.726442 °	-121.726442 °
DWR ID	DWR_RD1500_01_s_2012_18				
Comment Code					
BU : Building					
Inspector Comment

The corner of the building has encroached into the toe.
